# LIQUEFACTION EFFECTS AND ASSOCIATED DAMAGES OBSERVED AT THE WELLINGTON CENTREPORT FROM THE 2016 KAIKOURA EARTHQUAKE

## ABSTRACT

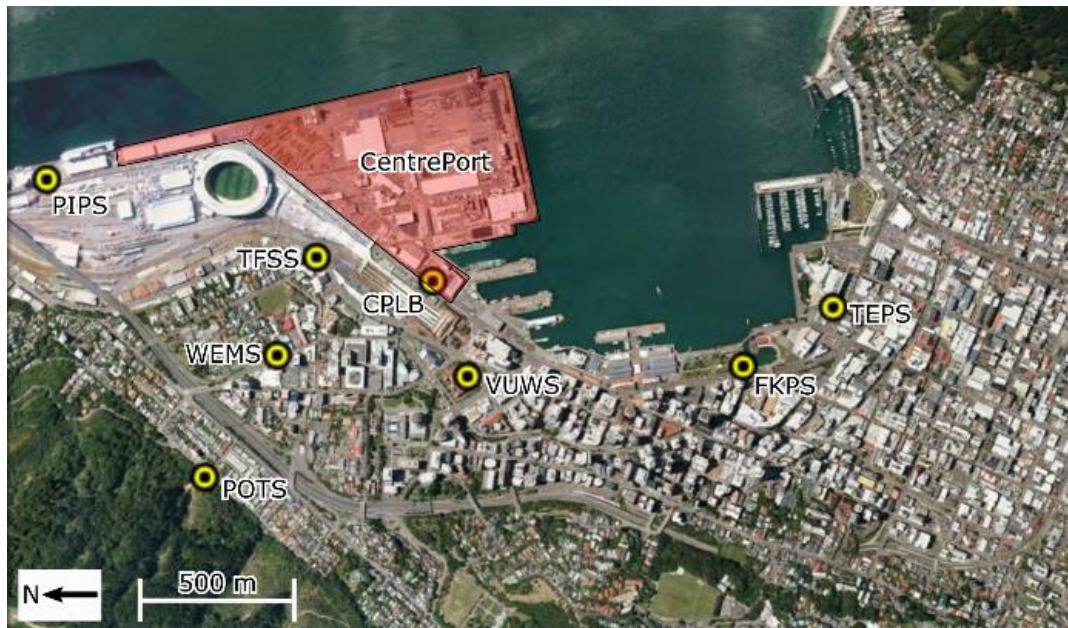
**Figure 1: Aerial view of Wellington highlighting CentrePort. The location of strong motion stations near CentrePort Wellington that recorded the Kaikoura earthquake are also shown (Base image from Google Earth™).**

Ground motions generated by the 2016 Kaikoura earthquake were recorded by a relatively dense array of strong motion stations (SMS) in Wellington as discussed further by Bradley et al. [12]. Figure 1 shows the locations of eight SMS that recorded the event near CentrePort Wellington. A summary of important information for the recorded accelerations and characteristics of the sites is given in Table 1, which includes: geometric mean horizontal peak ground acceleration (HPGA) recorded at the SMS during the 2016 Kaikoura earthquake,

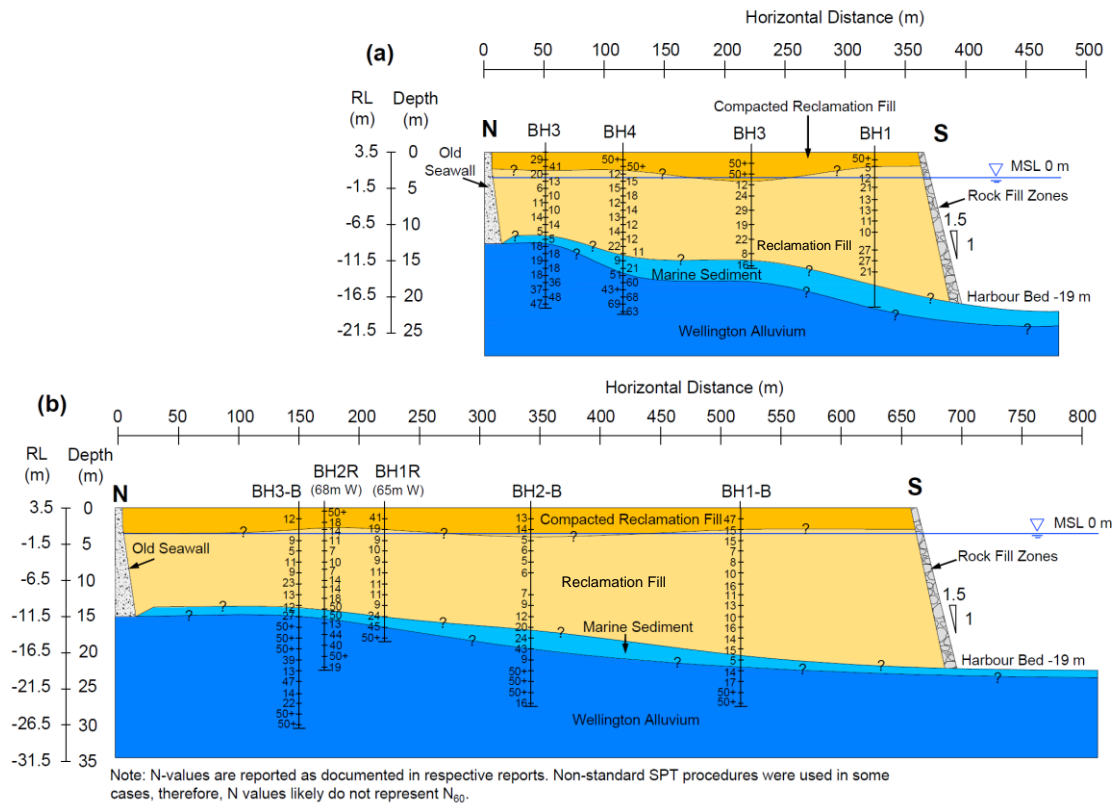
range between 13 and 50+ blows/300 mm [4, 9]. SPT  $N$  values of the soil layers from some of the available borings are indicated in the simplified cross-sections shown in Figure 4.

**Figure 4: Schematic soil cross sections illustrating key layers and their thicknesses at CentrePort; note the different horizontal and vertical scales for the cross sections; (a) N-S Cross section east of King’s Wharf; (b) N-S Cross section west of Thorndon’s Wharf.**

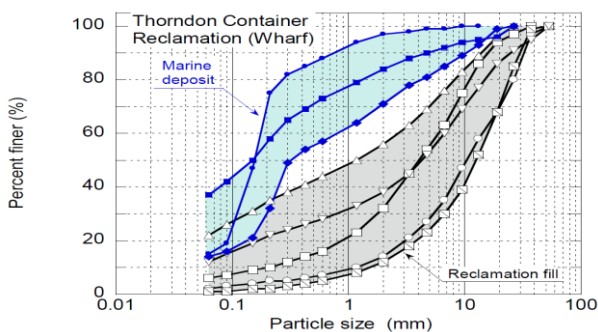
Figure 5 shows grain-size distribution curves for samples collected (prior to the Kaikoura earthquake) from subsurface explorations at locations approximately 5 to 40 m west of Thorndon Wharf. The fill is composed of gravelly soil including 10% to 40% sand and fines content of less than 15%. Comparative grain-size distribution curves for samples of the marine deposits are also shown in Figure 5. The test data indicate the marine deposits are predominantly sandy soils with fines content in the range between 15% and 35%.

**Figure 5: Grain-size distribution curves for borehole samples of the reclaimed fill and marine deposit.**

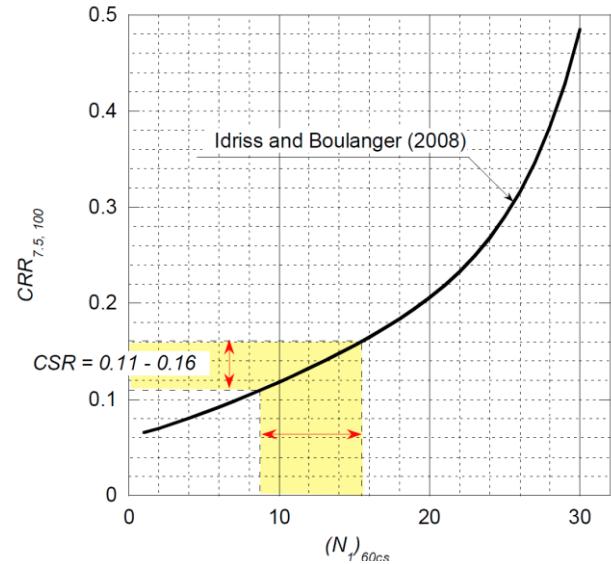
The estimated  $CSR_{wt}$  values for the SMS sites are summarized in Table 1.  $CSR_{wt} = 0.11 - 0.16$  for the three SMS sites closest to the port (i.e., CPLB, TFSS, and PIPS). This demand in terms of CSR is illustrated in Figure 8 together with the equivalent sand liquefaction resistance ( $CRR_{7.5,101}$ ) as a function of the SPT blow count (shown with the solid line), as defined in the semi-empirical liquefaction evaluation procedure of Boulanger and Idriss [15]. Note that the product of  $MSF \times K_{\sigma}$  in Equation (1) is approximately 1.0 for the combination of  $M_w 7.8$  earthquake and an effective overburden stress of about  $\sigma'_{vo} = 40$  to 60 kPa corresponding to a water table depth of 2 m to 3 m. Thus, the computed  $CSR_{wt}$  can be directly compared to the liquefaction resistance expressed in terms of  $CRR_{7.5,101}$  shown in Figure 8. If one accounts for the conservatism in this deterministic relationship of  $CRR_{7.5,101}$ , which corresponds to a 15% liquefaction probability [14], then the plot roughly indicates that the seismic demand was sufficient to trigger liquefaction in deposits having an equivalent clean sand SPT blow count of less than 10 to 14 blow counts. This simplified estimate of seismic demand applies to the soil at the depth of the ground water table and serves only as a rough indicator of the imposed seismic demand for assessing liquefaction triggering. The Boulanger and Idriss [15] CRR correlation was developed based on case histories on sandy soils, and therefore its applicability to gravelly soils is affected by several factors including the conversion of the penetration resistance of gravelly soils to an equivalent clean sand blow count. Hence, the plot shown in Figure 8 is only an indicator of the seismic demand in relative terms (i.e., in relation to an equivalent clean sand liquefaction resistance), and further research is needed to determine directly the cyclic resistance of the reclaimed deposits.

**Figure 8: Illustration of seismic demand induced by the 2016 Kaikoura earthquake for assessing liquefaction triggering at depth of the water table for the three sites on reclaimed soils in the vicinity of the port (i.e., PIPS, TFSS and CPLB).**

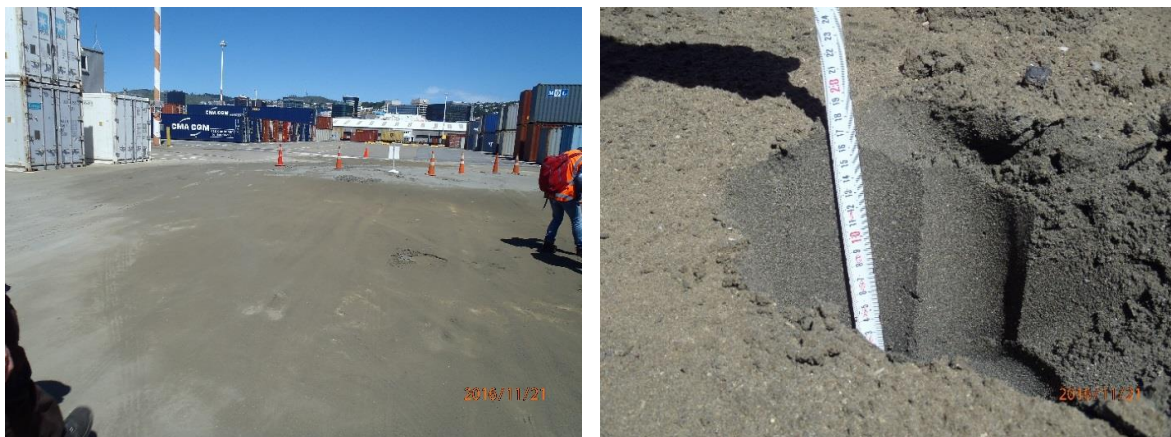
**Figure 10: Sandy liquefaction ejecta with trace gravel among area of 1970's end-dumped quarry rock reclamation (i.e., Thorndon Reclamation) at STA 145 and approximately 60 m west of the bulkhead. The ejecta deposit was approximately 170 mm thick at this location. Samples S11 and S12 were collected here (S41.279067° E174.788792°, taken on 21NOV2016).**

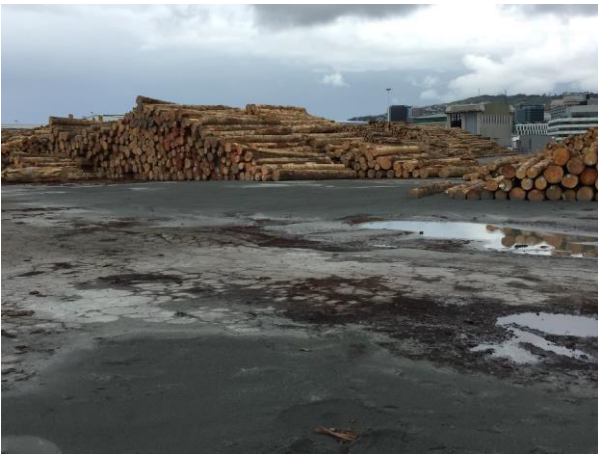
**Figure 11: Sandy liquefaction ejecta in the log stacking area (hydraulic fill reclamation) in the northeast corner of CentrePort (Sample S13). (S41.274972° E174.788347°, taken on 17 NOV16).**

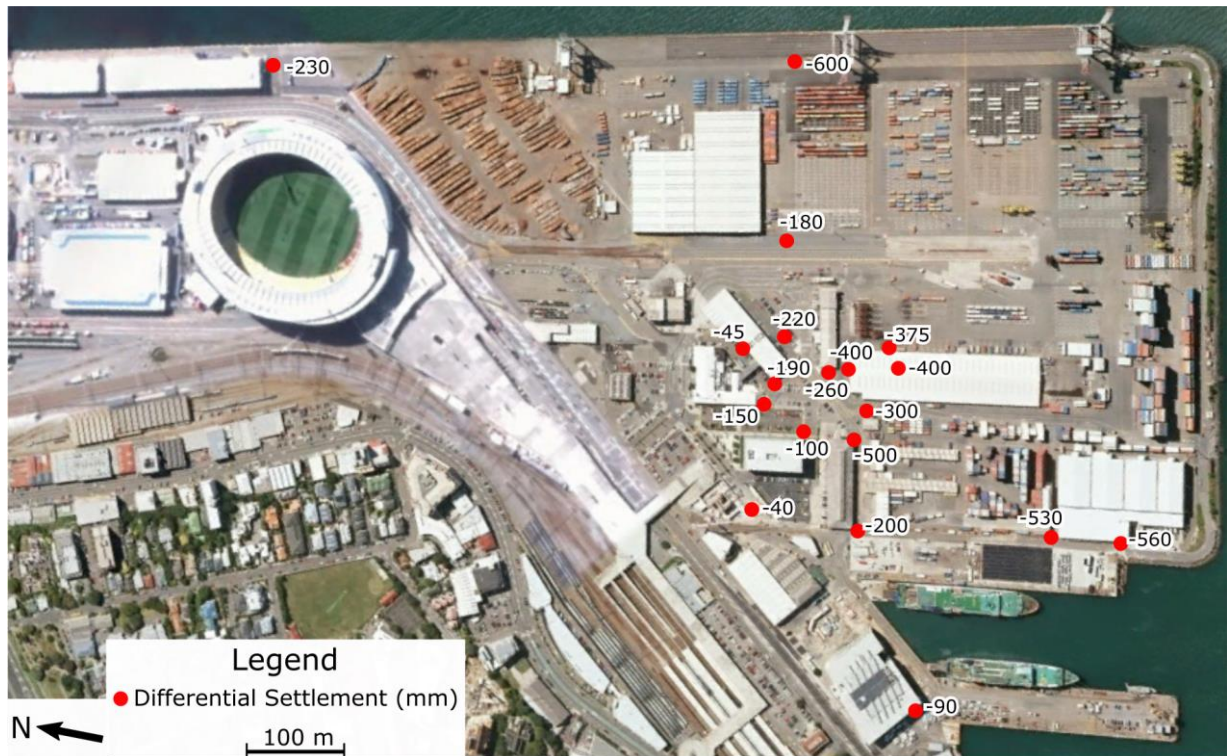
Differential hand-measured vertical settlement measurements are summarized in Figure 14. These measurements are of ground settlement relative to pile supported structures. Settlement of fill relative to buildings supported on a shallow foundation are excluded from this figure. The settlement of the fill south of the Old Seawall is generally in the range from 300 mm to 500 mm, whereas settlement of the order of 100 mm to 200 mm was observed in the hydraulic fill north of the seawall. The largest settlement was observed at one location at the Thorndon Container Terminal just behind the wharf where a vertical offset of about 600 mm was observed. Approximately 180 meters inland of the Thorndon Wharf bulkhead, 180 mm of settlement were measured relative to what appeared to be the buried piles of the historic gantry crane (Figure 3).

Figure 14: Location and magnitude of differential settlement measurements obtained during inspections. All values are in mm, and represent settlement of the ground surface relative to a pile supported structure (Base image from Google Earth™).

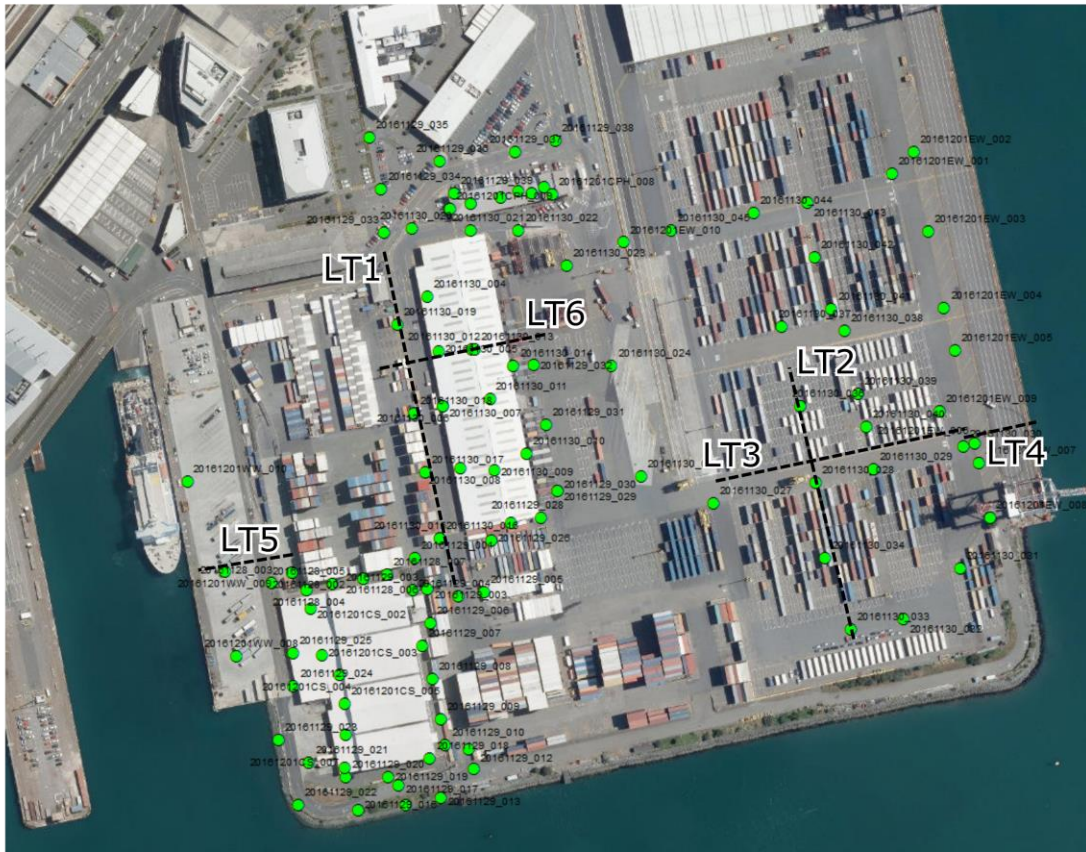
Figure 16: Locations (green circles) where ground-based LiDAR scans were obtained at the CentrePort. Additional scans were captured inside the Cruise Ship Terminal to the North that are not shown. Transects from the LiDAR data shown later in the report are identified. Note that the basemap is from ESRI prior to the earthquake.

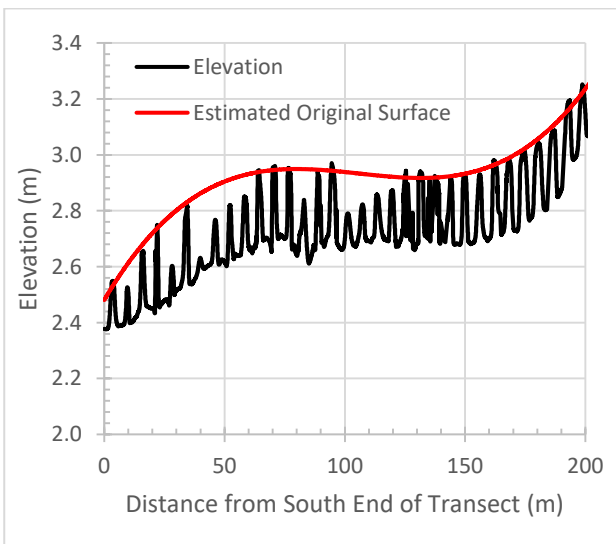
Figure 17 shows a cross-section (LT1) extracted from the LiDAR data that was obtained on the west edge of the road immediately west of Building S37. The peaks in this plot indicate locations of the buried piles whereas the lower portions show the magnitude of settlement of the pavement surface around those piles. In absence of detailed survey data prior to the event, the original surface was estimated by fitting a 3<sup>rd</sup> order polynomial ( $R^2 = 0.99$ ) to the tops of piles showing higher elevations in the local area. Using this assumption, a differential settlement of the ground (settlement of the ground relative to the ground surface covering the tops of the piles) in this area was estimated to be on the order of 200 mm to 300 mm. LiDAR surveying data on the performance of wharves and buildings are presented in the subsequent sections.

Figure 17: Post-earthquake elevations for transect (LT1) along west side of roadway west of S37; the red line represents the estimated pre-elevation surface.

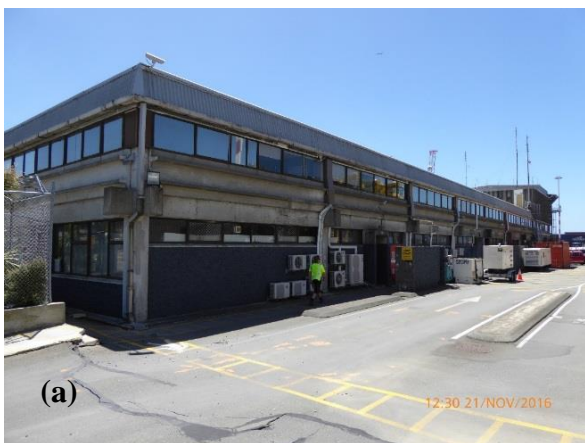
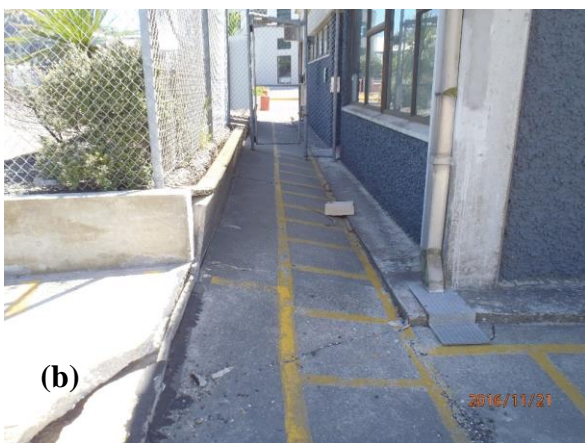
The CPH building (S41.27829° E174.78618°, see Figure 24) is founded on reinforced concrete (RC) spread footings connected with RC grade beams (Figure 25a). There were no apparent signs of structural distress, and the building was operational at the time of the reconnaissance in late November 2016. The building and immediately surrounding fill settled relatively uniformly. Settlement appeared to be more or less uniform across the building footprint, as there were no apparent signs of relative movement or tilt of the ground floor of the CPH building from the visual investigation. However, a preliminary analysis of the LiDAR scans indicate a slight tilt (i.e., of 0.105 degrees) in the large operations room on the east end of the building. Ground a few meters to the west of the CPH building did not appear to settle significantly, because it was supported by the buried precast seawall that ran along the bulkhead of the partially demolished Pipitea Wharf, which minimized liquefaction-induced settlement of the ground above it. The building and fill settled approximately 230 to 260 mm relative to the elevated ground supported on the seawall (Figure 25b).

**Figure 25:** (a) Uniform settlement of CPH building which is founded on shallow foundations that apparently displaced downward the same amount as the surrounding fill. This photo is looking northeast at the southwest corner of the building. (S41.278395° E174.785639°, taken on 21NOV16). (b) Uniform settlement (230–260 mm) of the building relative to ground supported on the buried precast seawall that ran parallel to the bulkhead of partially demolished Pipitea Wharf. Looking north along western wall of CPH building. The perimeter walkway slopes down towards the building at 11 degrees over 1.35 meters. (S41.278395° E174.785639°, taken on 22NOV16).

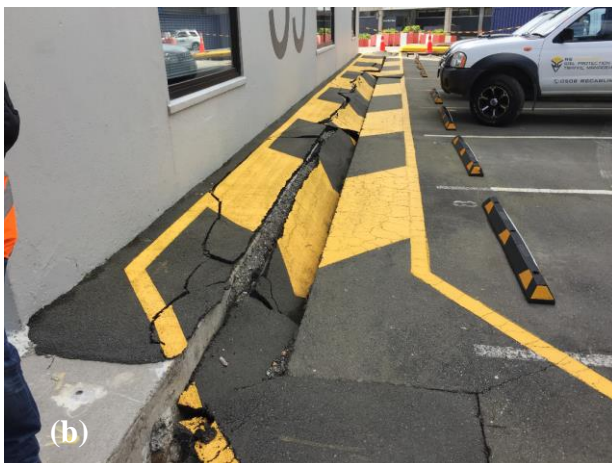
The S39 building (see Figure 24) is supported on Frankie piles. The old buried mass concrete seawall (i.e., Old Seawall) runs parallel and adjacent to the southeast wall of the building. Additionally, along the southeast wall, a segment of the historic Fryatt Quay Wharf deck (Figure 3) was left intact. The ground to the south of the seawall and wharf settled 220 mm relative to the top of the wharf deck and the pile-supported building (Fig. 33a). Approximately 100 to 190 mm of settlement was observed along the southwest wall of the building (Figure 33b). On the northwest side of the building, the ground adjacent the building settled approximately 50-100 mm relative to the building. The

**Figure 33: (a) Southeast side of Building S39 and a buried segment of the Fryatt Quay Wharf deck parallel to the building. Fill to the south of the buried mass concrete seawall/wharf settled 220 mm relative to the pile-supported building and wharf deck. ( $S41.277984^{\circ}$   $E174.785776^{\circ}$ , 22NOV16), and (b) looking southeast along southwest wall of Building S39. Fill settled approximately 190 mm relative to pile-supported building at the northwest corner of the building (shown on lower left corner of photo), and magnitude of settlement decreased south-eastward along this wall. ( $S41.277994^{\circ}$   $E174.785467^{\circ}$ , 17NOV16).**

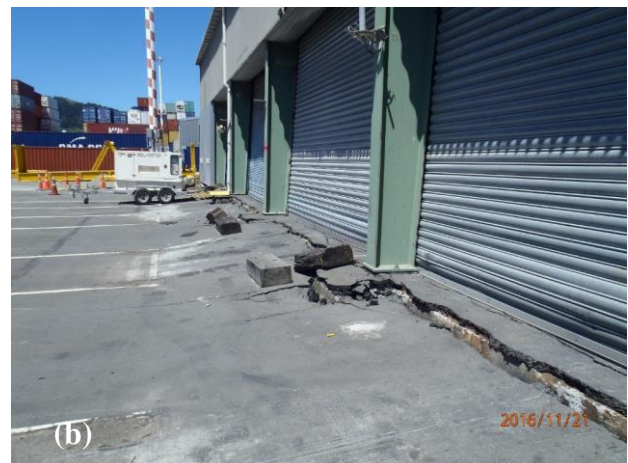
The western half of the S37 building (see Figure 24) is founded on the deck of the buried, partially demolished pile-supported Pipitea Wharf, and the east wall of the building is supported on piles. The precast seawall that formerly ran along the bulkhead of the Pipitea Wharf is now buried and runs south-to-north through about the centerline of the building. The ground floor slab not supported on piles, the old wharf deck, or the precast seawall settled up to 550 mm relative to these structures (Figure 34a; the value is based on measurement from LiDAR scan for this building). The ground settled approximately 375 mm relative to the building along the exterior of the east wall of the S37 building (Figure 34b). Approximately 16 m west of the western wall of the S37 building, a buried row of piles from the old Pipitea Wharf protruded from the ground as the surrounding fill settled approximately 300 mm relative to the piles (Figure 17).

**Figure 34: (a) Looking west across north wall of Building S37. Approximately 400mm of differential settlement between ground and deck of buried, pile-supported Pipitea Wharf that supports the western side of the shed. ( $S41.278571^{\circ}$   $E174.785632^{\circ}$ , 21NOV16); and (b) looking south along east wall of Building S37, which shows approximately 375 mm of differential settlement between fill and pile-supported east wall of the building. ( $S41.279065^{\circ}$   $E174.785787^{\circ}$ , 21NOV16).**

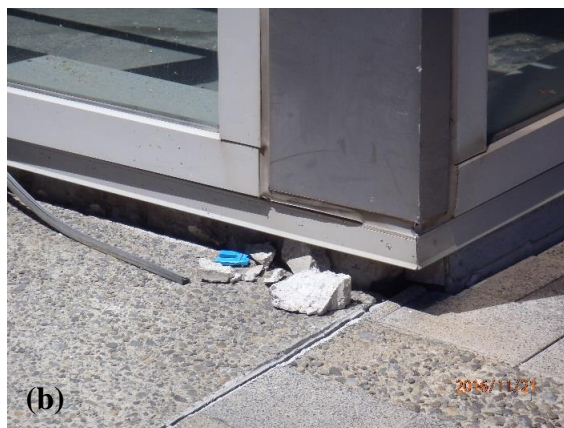
The B building (see Figure 24) is supported on piles with stone column ground improvement performed over the southeastern (seaward) half of the building footprint. The surrounding ground settled approximately 50 to 90 mm uniformly relative to the building (Figure 36). No other significant movements were observed.

**Figure 36: Ground settlement relative to the pile-supported B building at: (a) the southwest corner of the building with ground improvement (S41.279767° E174.782100°, 21NOV16), and (b) northwest corner of the building without ground improvement (S41.279419° E174.781443°, 21NOV16).**
